## **IMPORTANT SAFETY NOTICE REGARDING MEDICAL OXYGEN CYLINDERS**

January 26, 2007

**IMPORTANT SAFETY NOTICE**  
**REGARDING MEDICAL OXYGEN CYLINDERS**

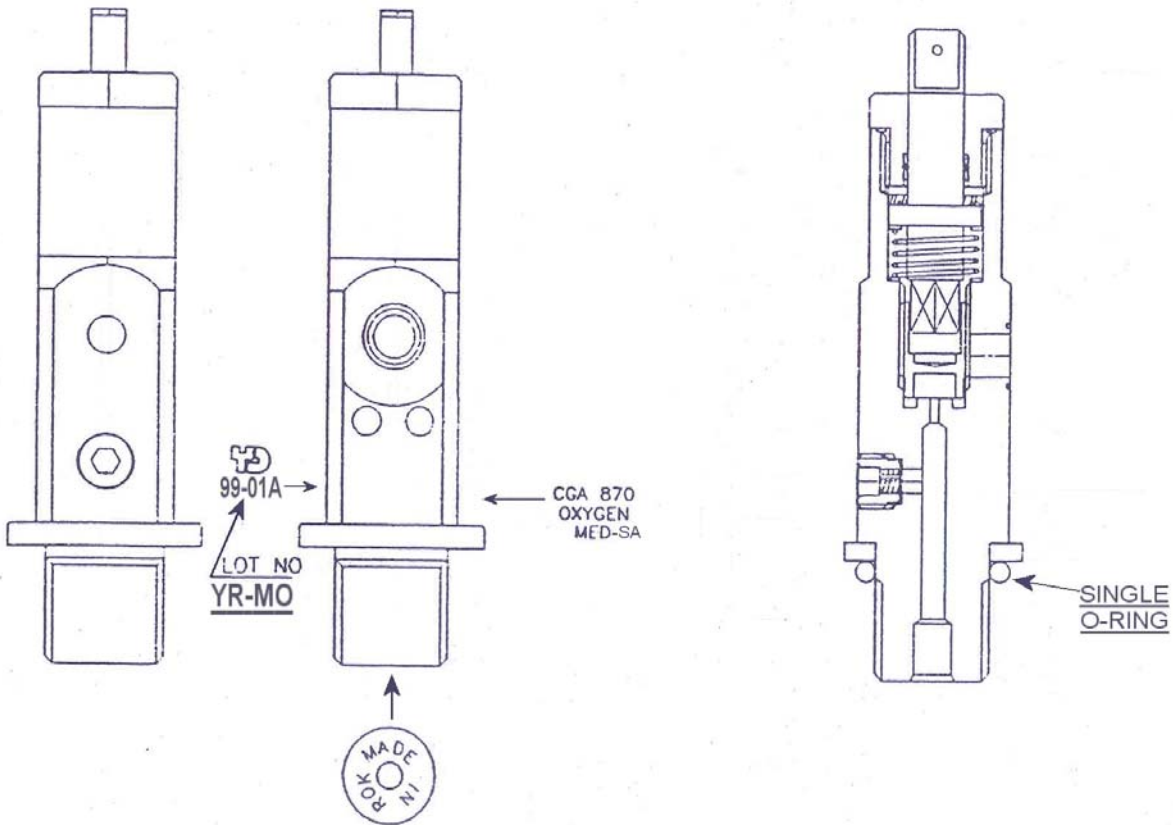
This notice regards Young-Do CGA 870 straight threaded post valves single o-ring design. As shown in the diagram below, these valves have the Young-Do logo

engraved on the valve, along with the manufactured year of 99, 00, 01 or 02 as the first two digits of the lot number. The valves can be in the wrench, toggle or hand wheel configuration.

The products that are the subject of this notice are Catalina aluminum cylinders that were fitted with Young-Do CGA 870 post valves (single o-ring design). Catalina purchased and installed these valves between February 1999 and March 2003. As the attached diagram shows, the valves can be identified by the Young-Do logo and a lot number beginning with the numbers 99, 00, 01, or 02 (for year of manufacture). The Catalina cylinders are marked either “M4002 . . . CATALINA” or “CLIFFDIV,” each followed by a serial number, and have a warning label with the Catalina logo attached to the side of the cylinder.

- If it is, the home health agency should check the cylinder for loss of content.
- If there is loss of content, the home health agency or filler should investigate the possible causes. They may include a damaged or worn o-ring, improper torque of the valve in the cylinder, an issue with the operation of the valve, or damage to the cylinder gland (where the o-ring sits). In many instances, a simple repair or replacement of the o-ring will adequately address the problem. In some circumstances, however, it may be necessary to replace the valve. All maintenance should be conducted by qualified personnel to current industry standards. The single o-ring valve relies on one o-ring for seal integrity, and care should therefore be taken during o-ring replacement to avoid damage during installation.
